SUSTAINABLE
RUNOFF SOLUTIONS

Routine Maintenance Always Saves Money: How to be Pro-Active

1 Permeable Interlocking Concrete Pavers (PICP)

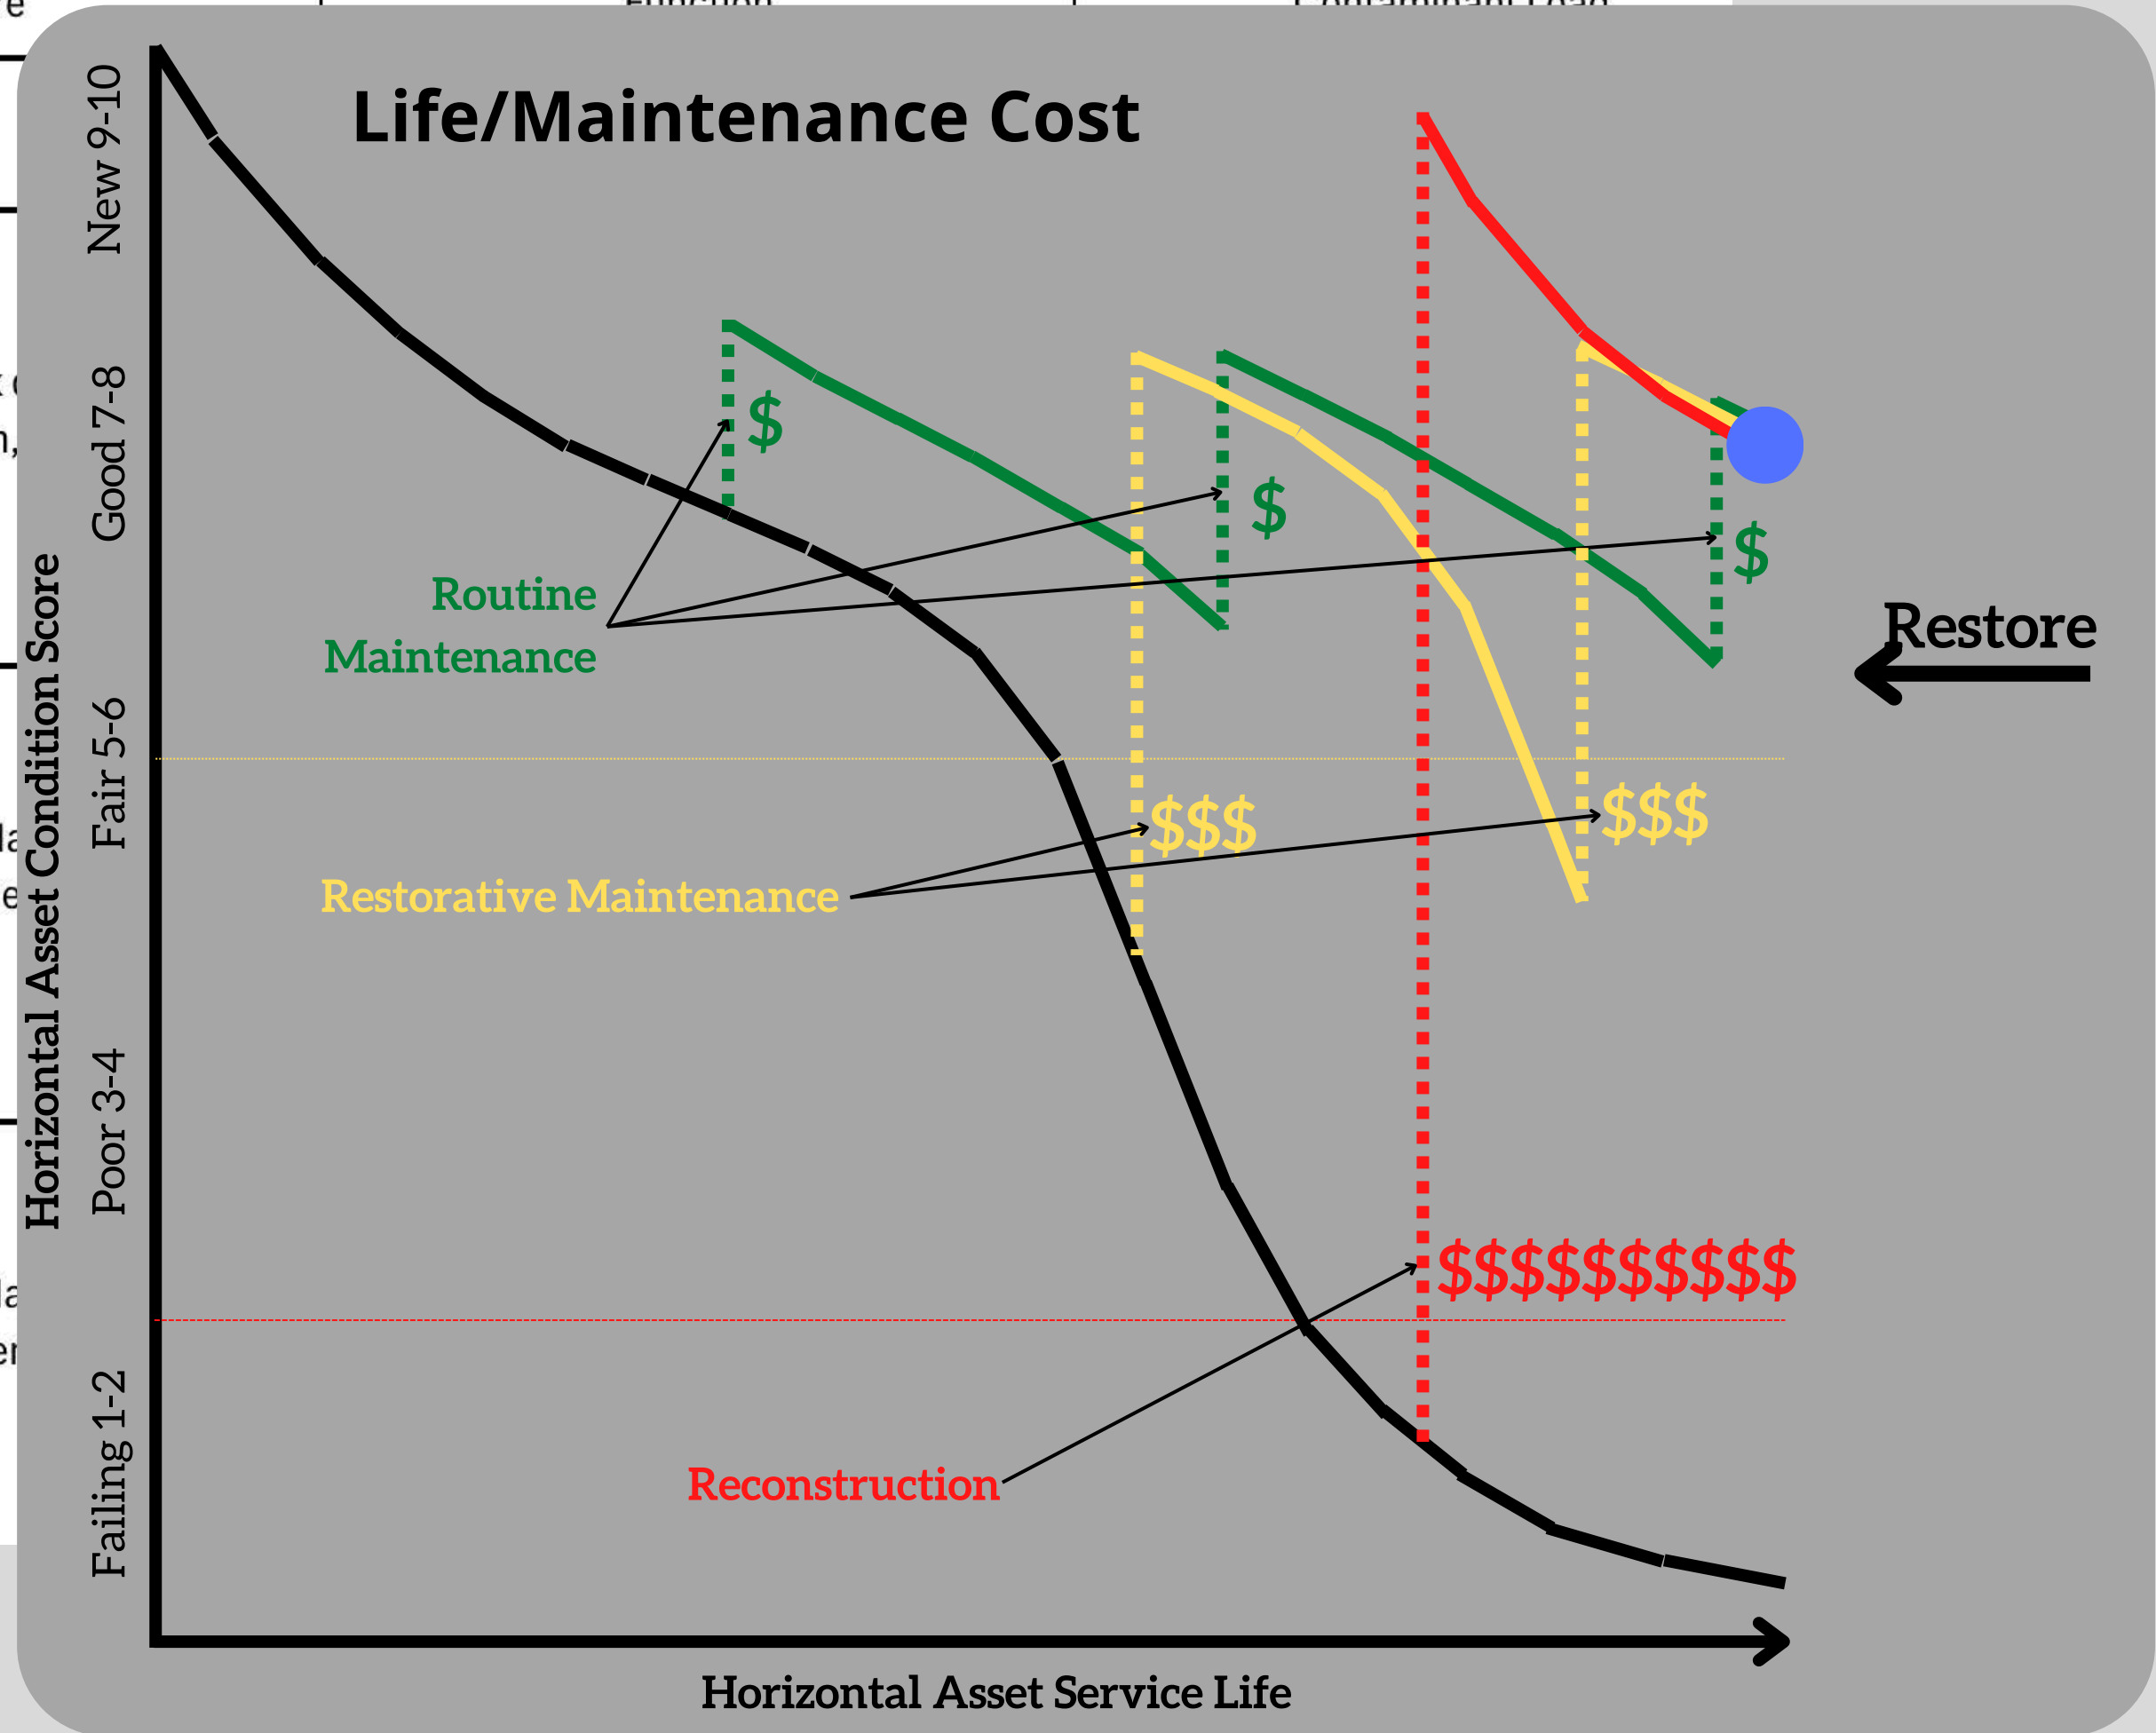
Condition Score	Permeable Interlocking Concrete Pavers (PICP)		
		Structure	Function	Contaminant Load
Routine Maintenance	10			
	9			
	8	Limited to no paver block		
	7	block settlement < 1-inch, cracking		
Restorative Maintenance	6			
	5	Some paver block degradation		
	4	settlement < 1-inch, some cracking		
Reconstruction	3			
	2	Major paver block degradation		
	1	paver blocks, block settlement, major boarder cracking

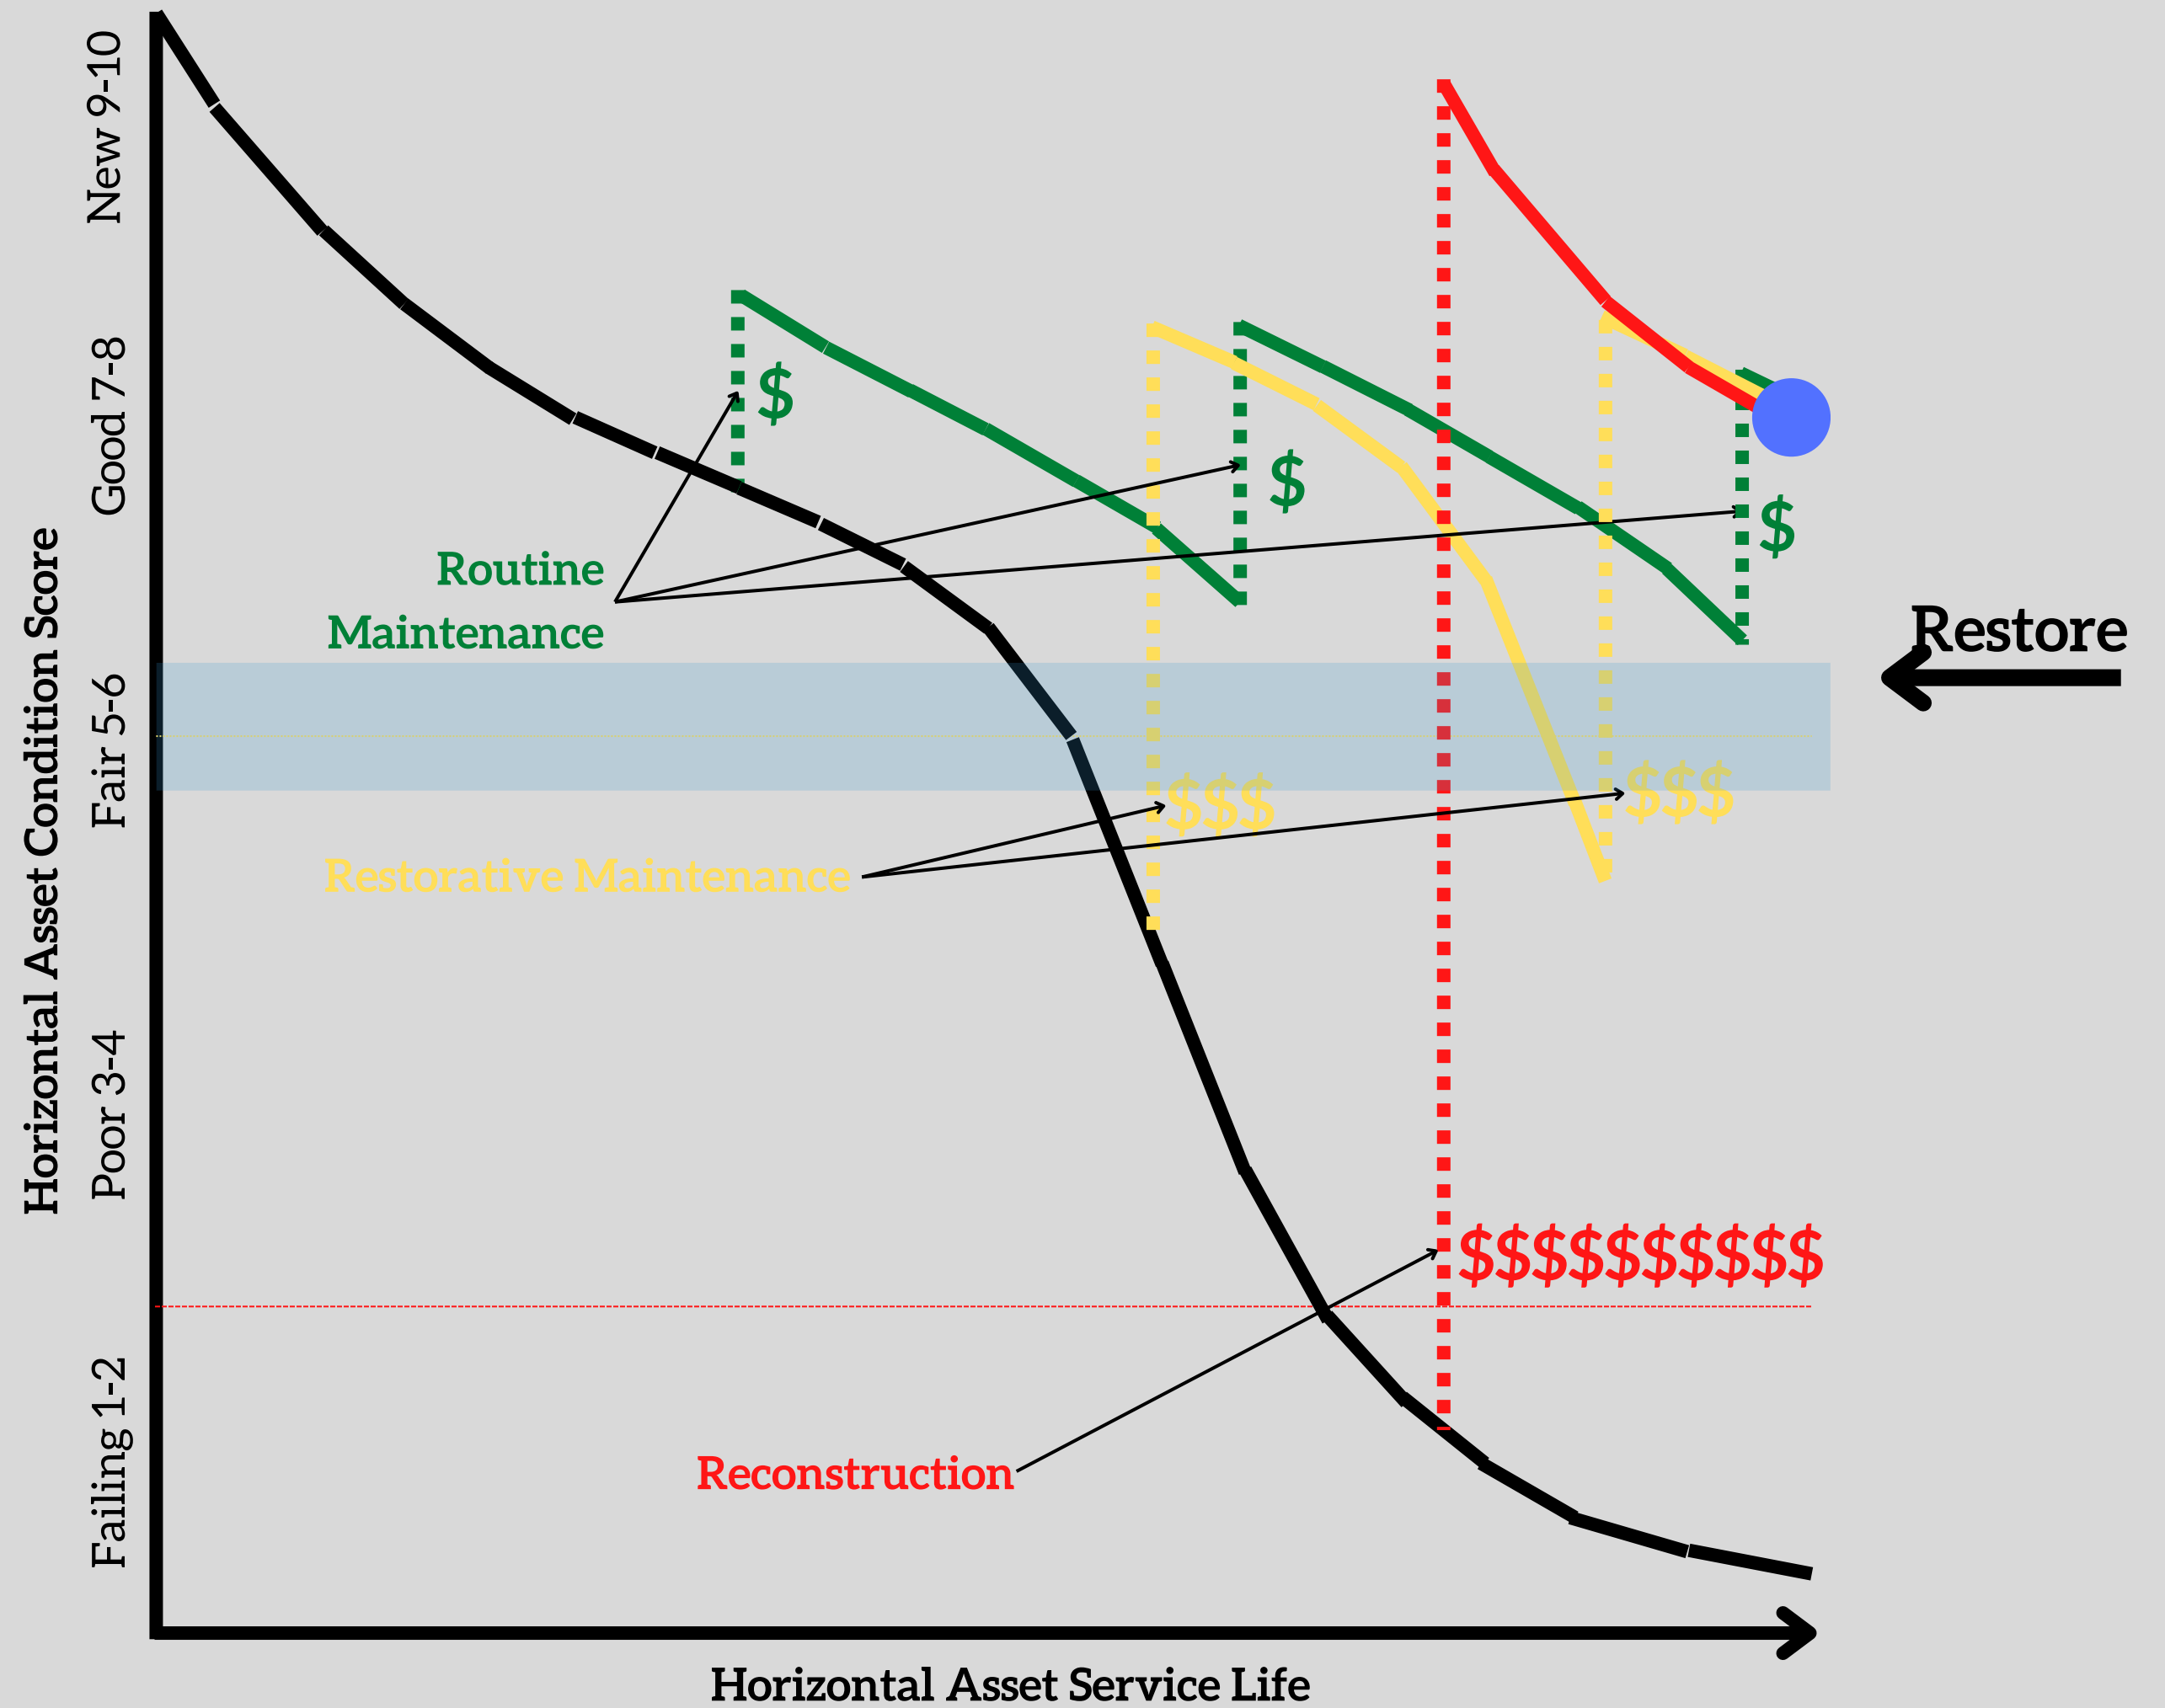
Client A: Permeable Interlocking Concrete Pavers

Client A
Pavers Noncompliant
Restoration Complete
Pavers Compliant
Routine maintenance will keep pavers compliant

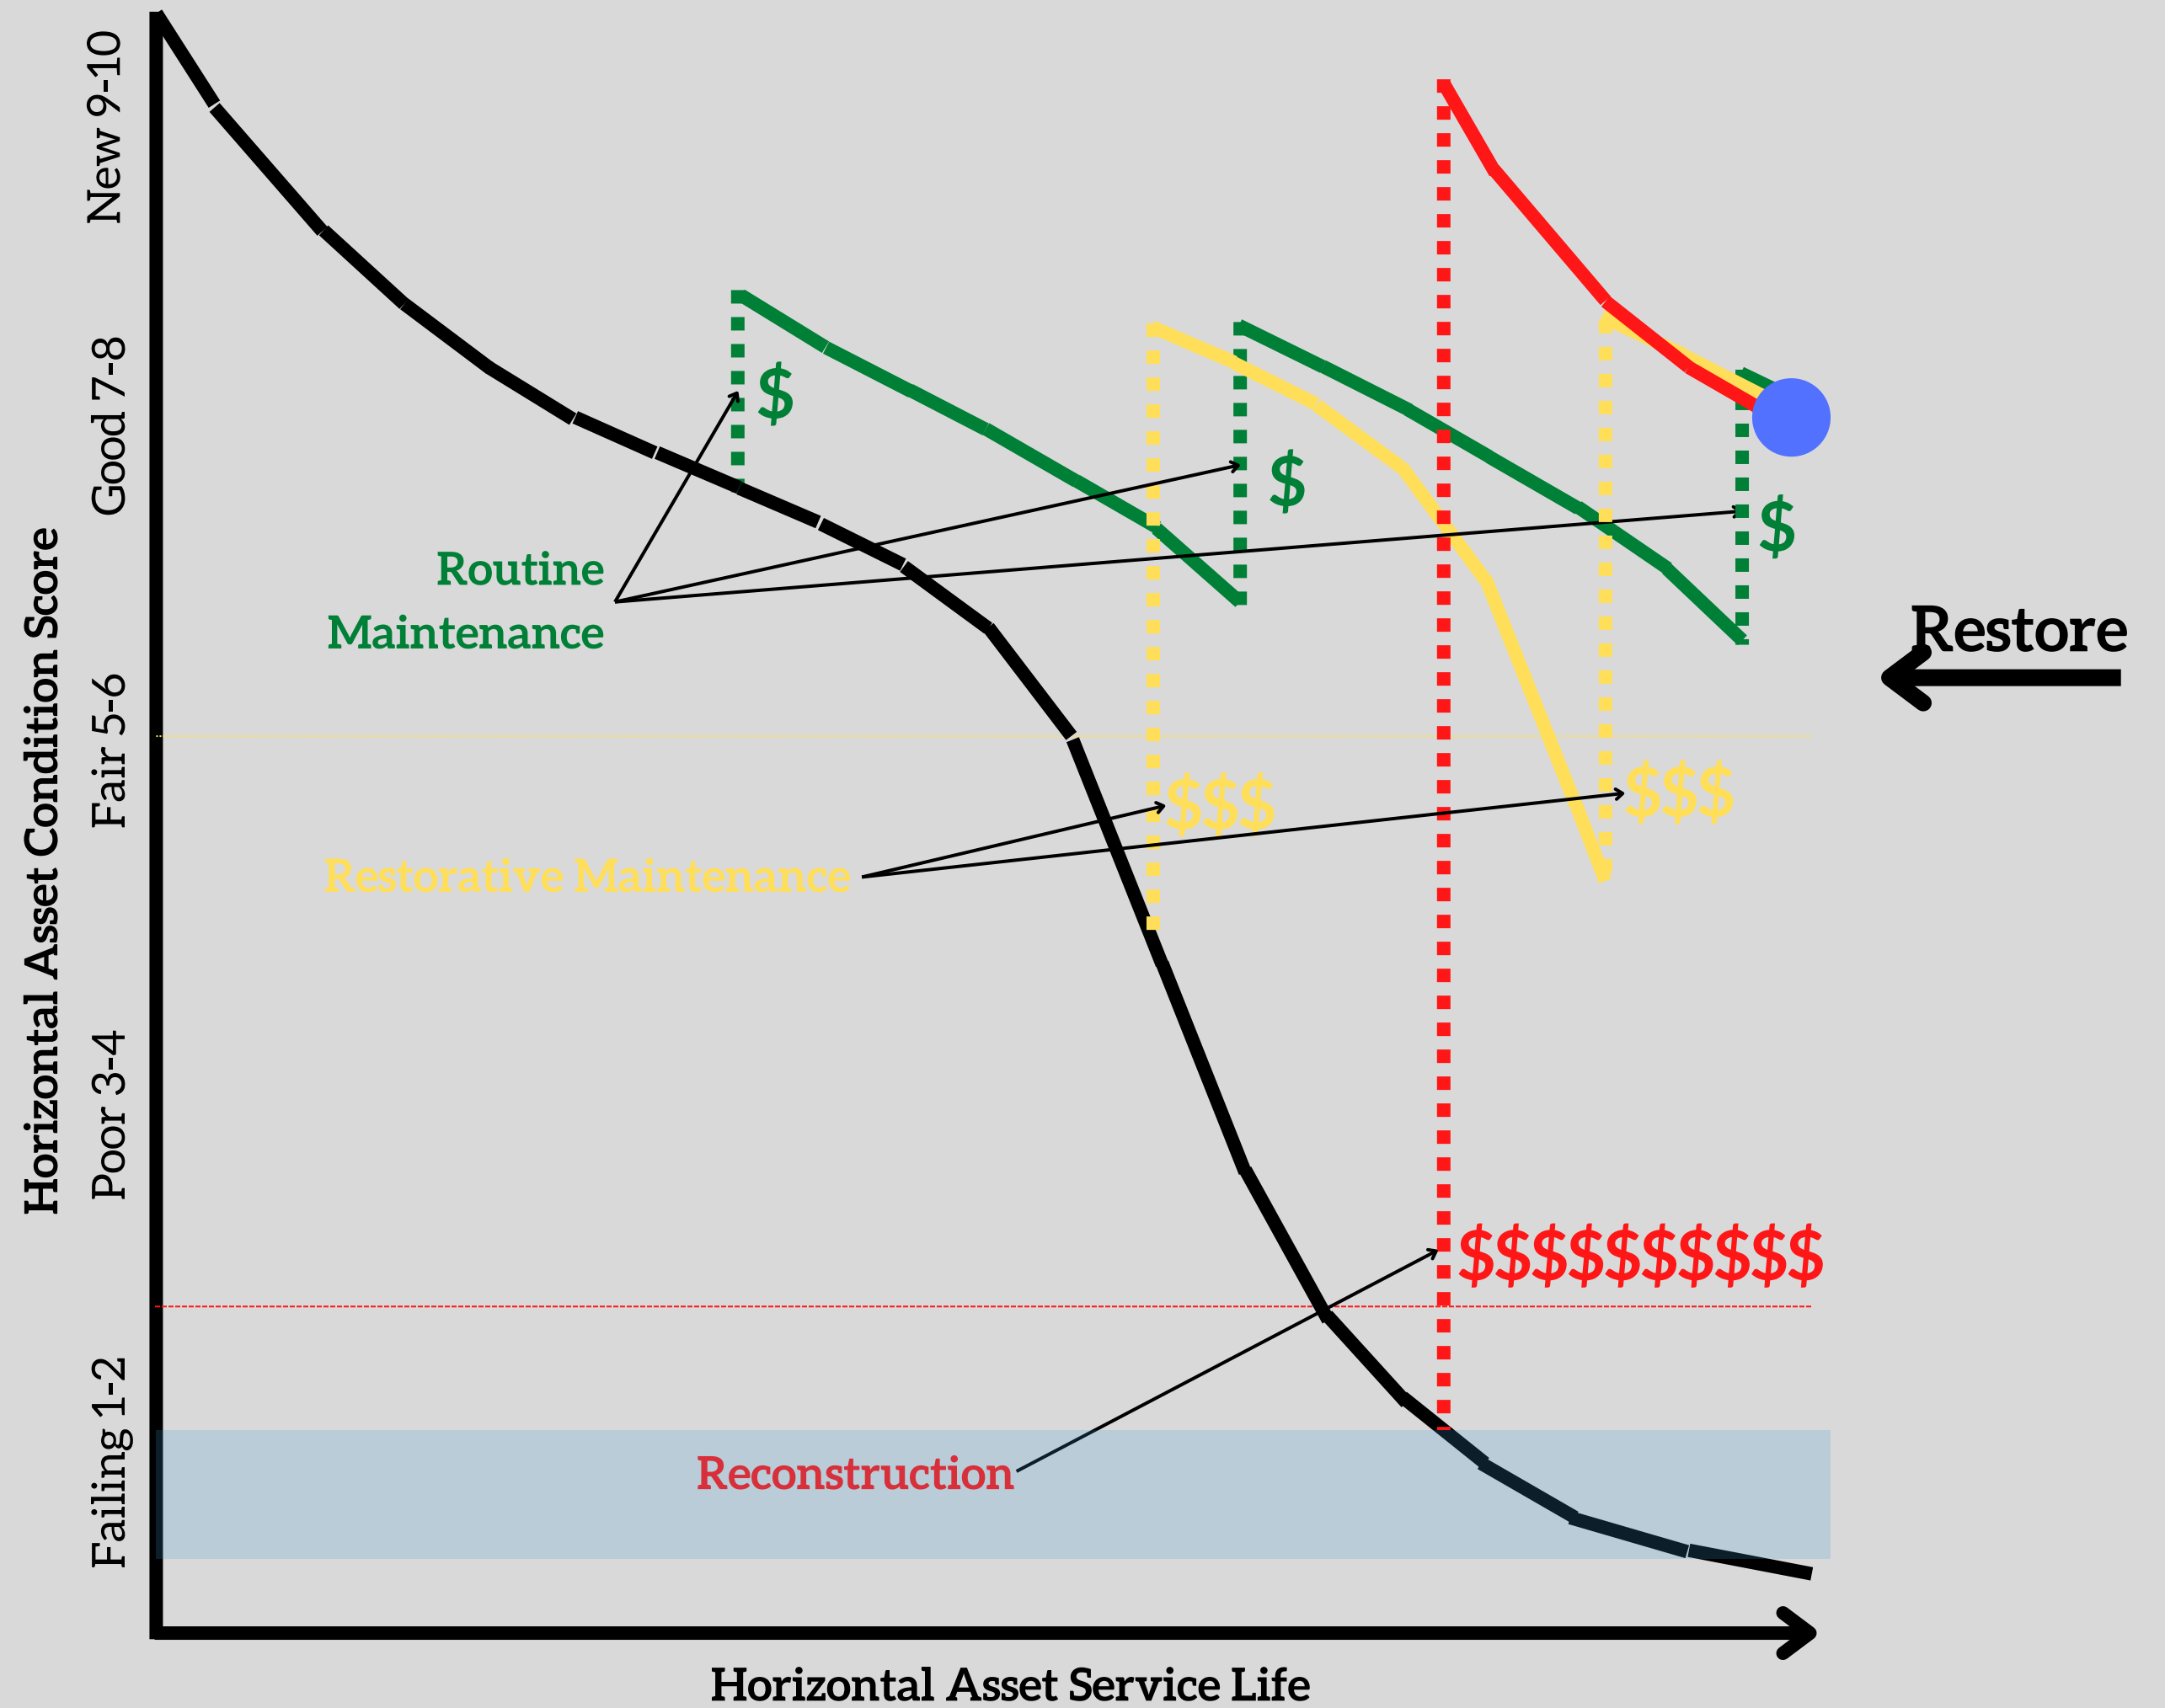
Client B: Permeable Interlocking Concrete Pavers

Client B	
Pavers Noncompliant	
Restoration Complete	
Pavers Noncompliant	
Pavers must be reconstructed to be compliant

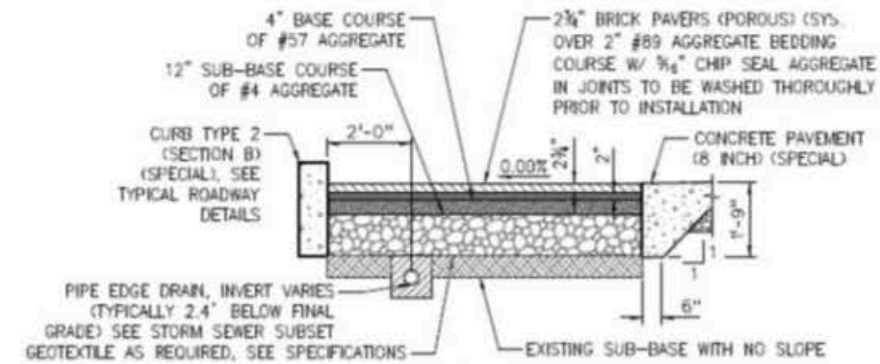
Figure 1. Pearl Pkwy Permeable Pavement Cross Section

Pearl Parkway between 30th St and the BNSF railroad was reconstructed in 2014 to integrate a multi-use path and improved access to the Boulder Junction development sites by incorporating off street multiway boulevards. The 24 parking stalls of the boulevard lanes are permeable pavement systems designed to capture stormwater runoff.

1. **Removal and Reinstallation:** Remove existing pavers, clean underlying debris buildup, reinstall 2" of clean bedding layer, and replace pavers and joint aggregate. Unit Cost Range: \$8-\$10/ft².
2. **Restorative:** Remove debris buildup from joints by pressure washing and using a high-pressure vacuum, then replace joint aggregate. Unit Cost Range: \$3-\$4/ft².
3. **Routine:** Sweep and vacuum using a regenerative air street sweeper and lawn/debris vacuum in tighter areas at 6-month intervals in 2024 and 2025 following initial maintenance actions. Unit Cost Range: \$0.50-\$1/ft².

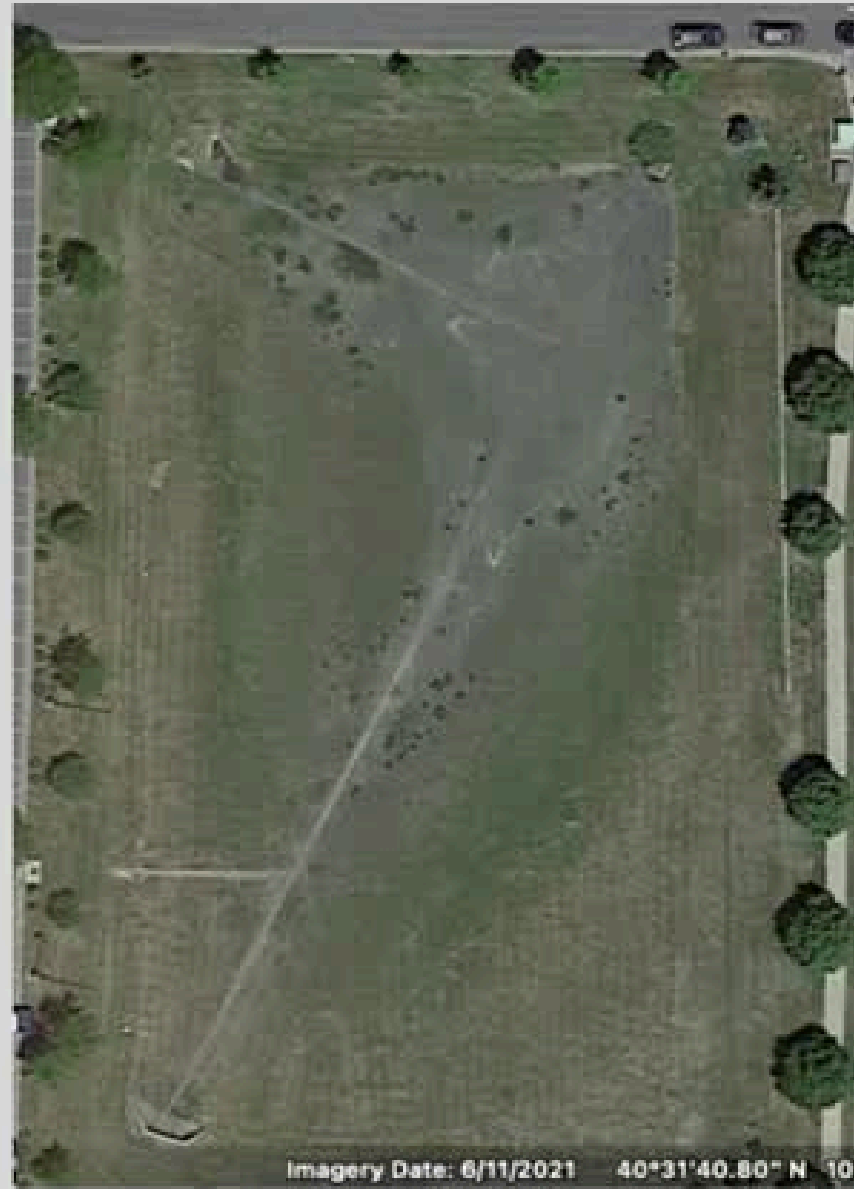
6/11/21 right before
first SRS
maintenance 7/21

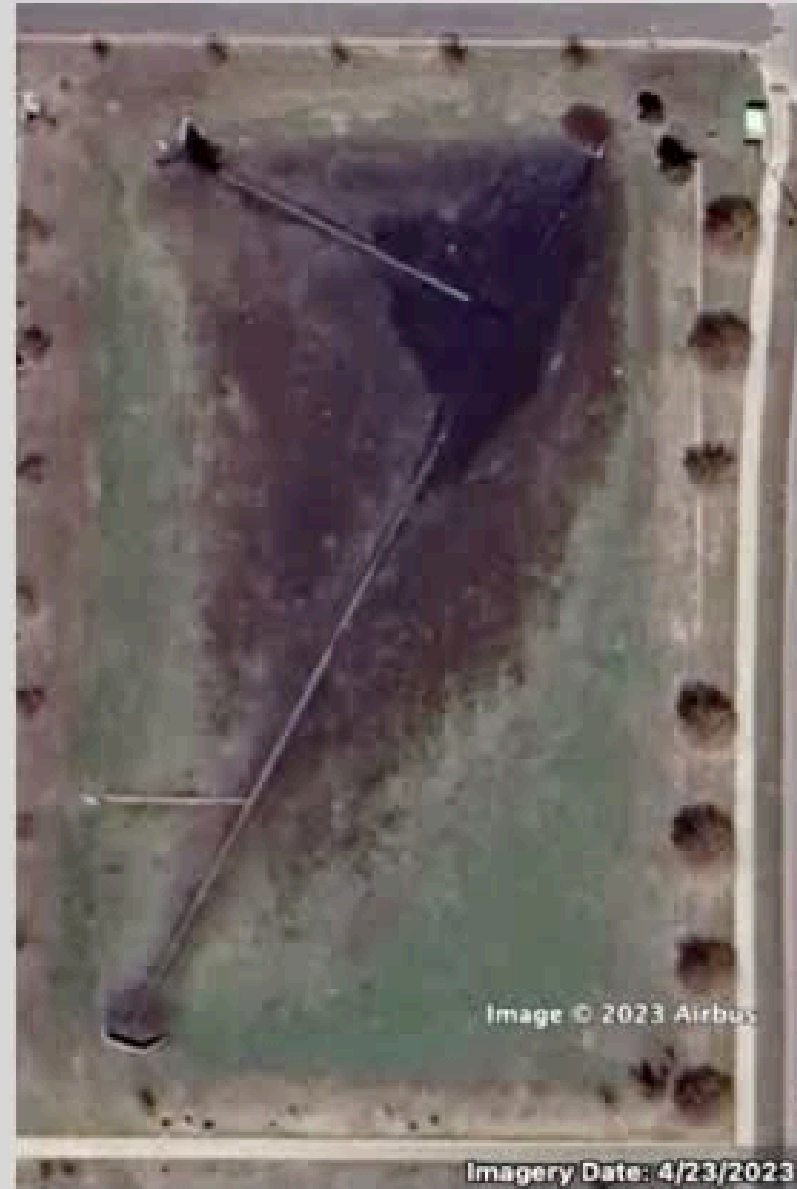
4/23/23 right before
4th SRS
maintenance 5/9

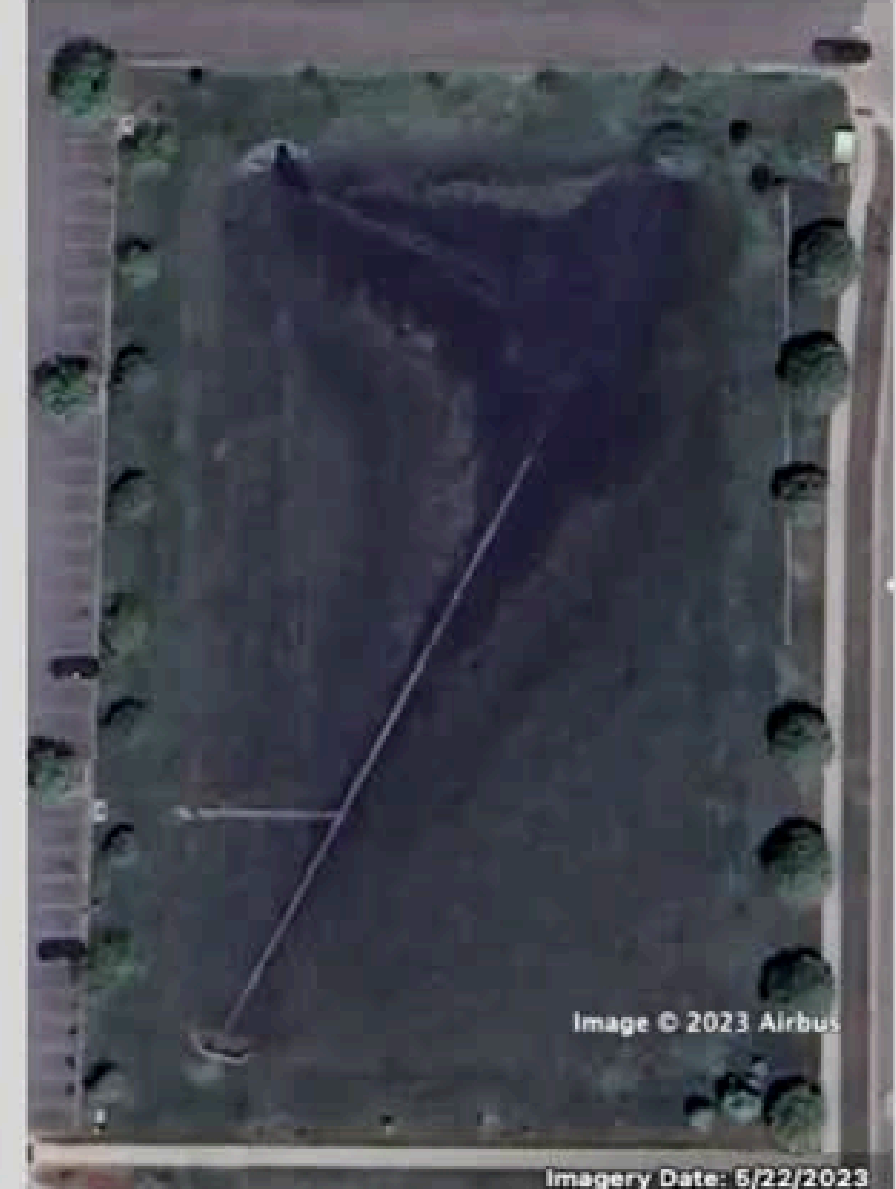
5/22/23 right after
4th SRS
maintenance 5/9

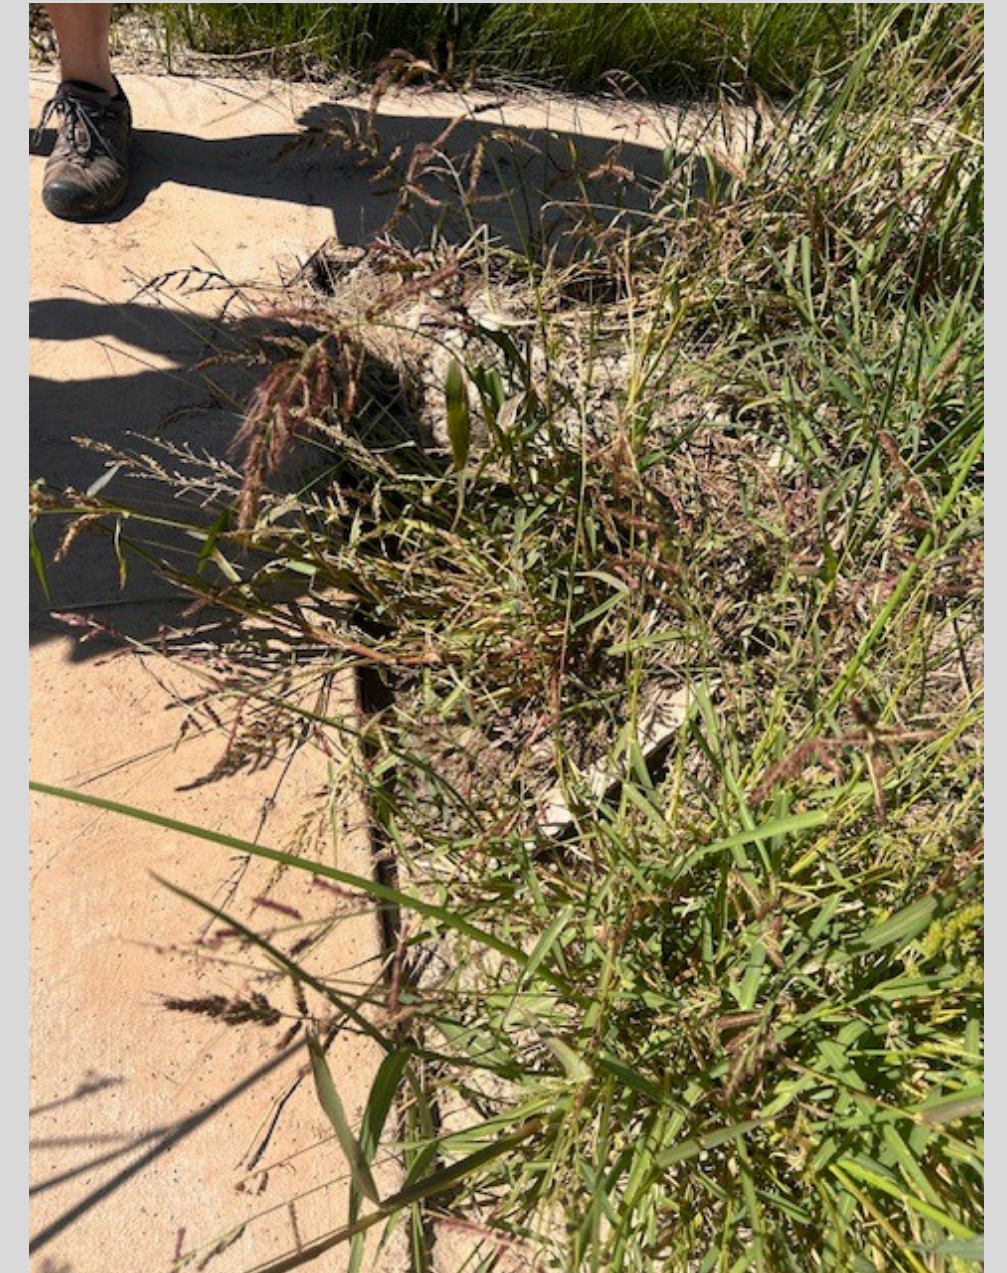
Client A:	Nonstandard MS4 Permit Administration
Lesson:	Perform construction SWMP inspections with an eye toward long-term operation and maintenance of drainage systems

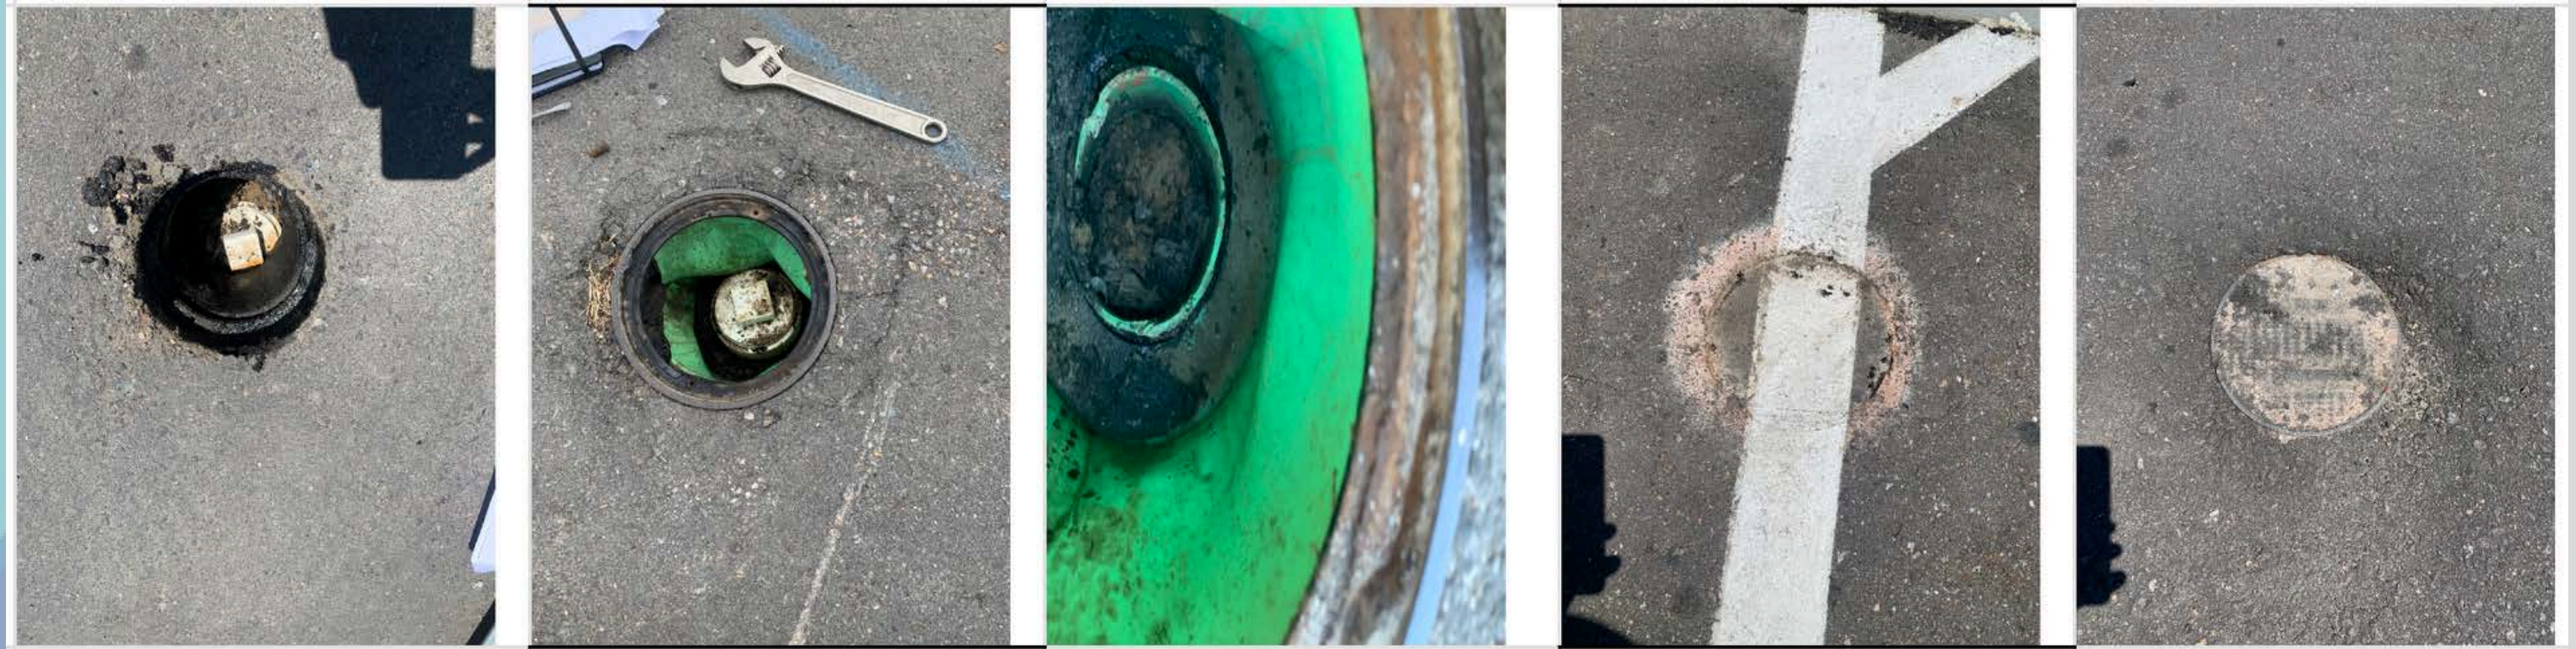
Client B:	Underground SCM with 6 Isolator Rows
Lesson:	Inspect assets while under warranty, inspect SCM access after projects like paving

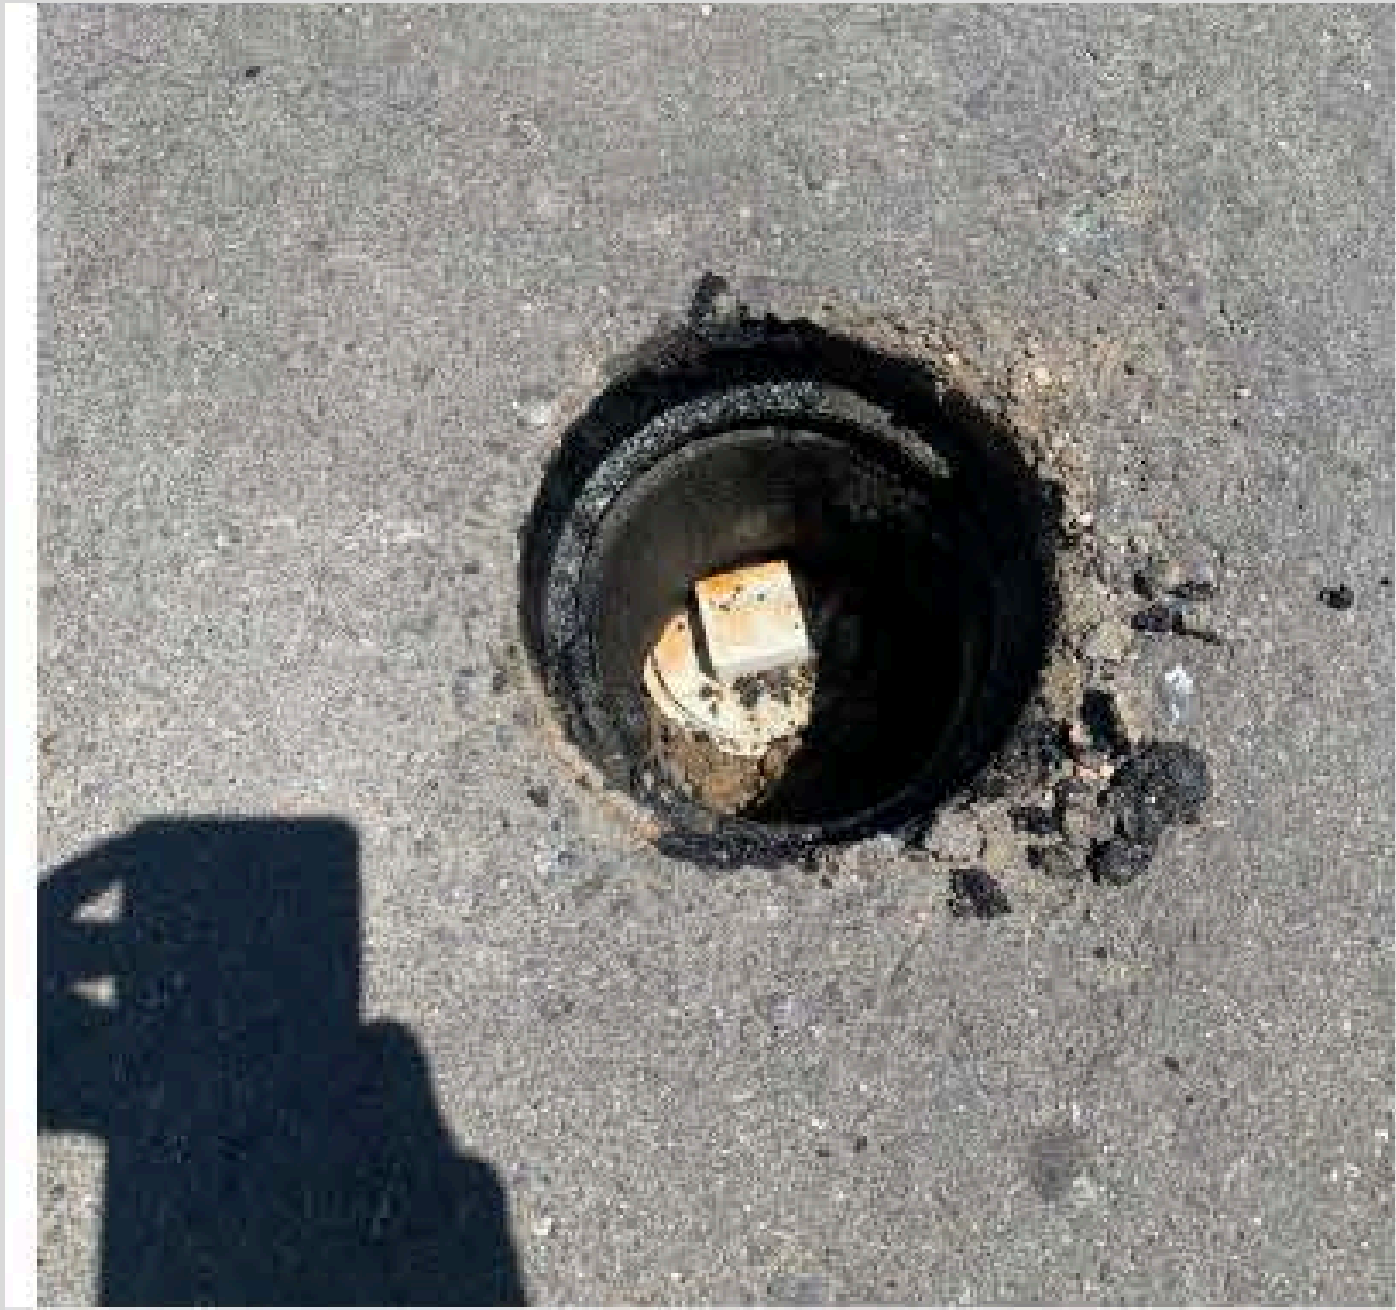
Client B:	Underground SCM with 6 Isolator Rows
Lesson:	Inspect assets while under warranty, inspect SCM access after projects like paving

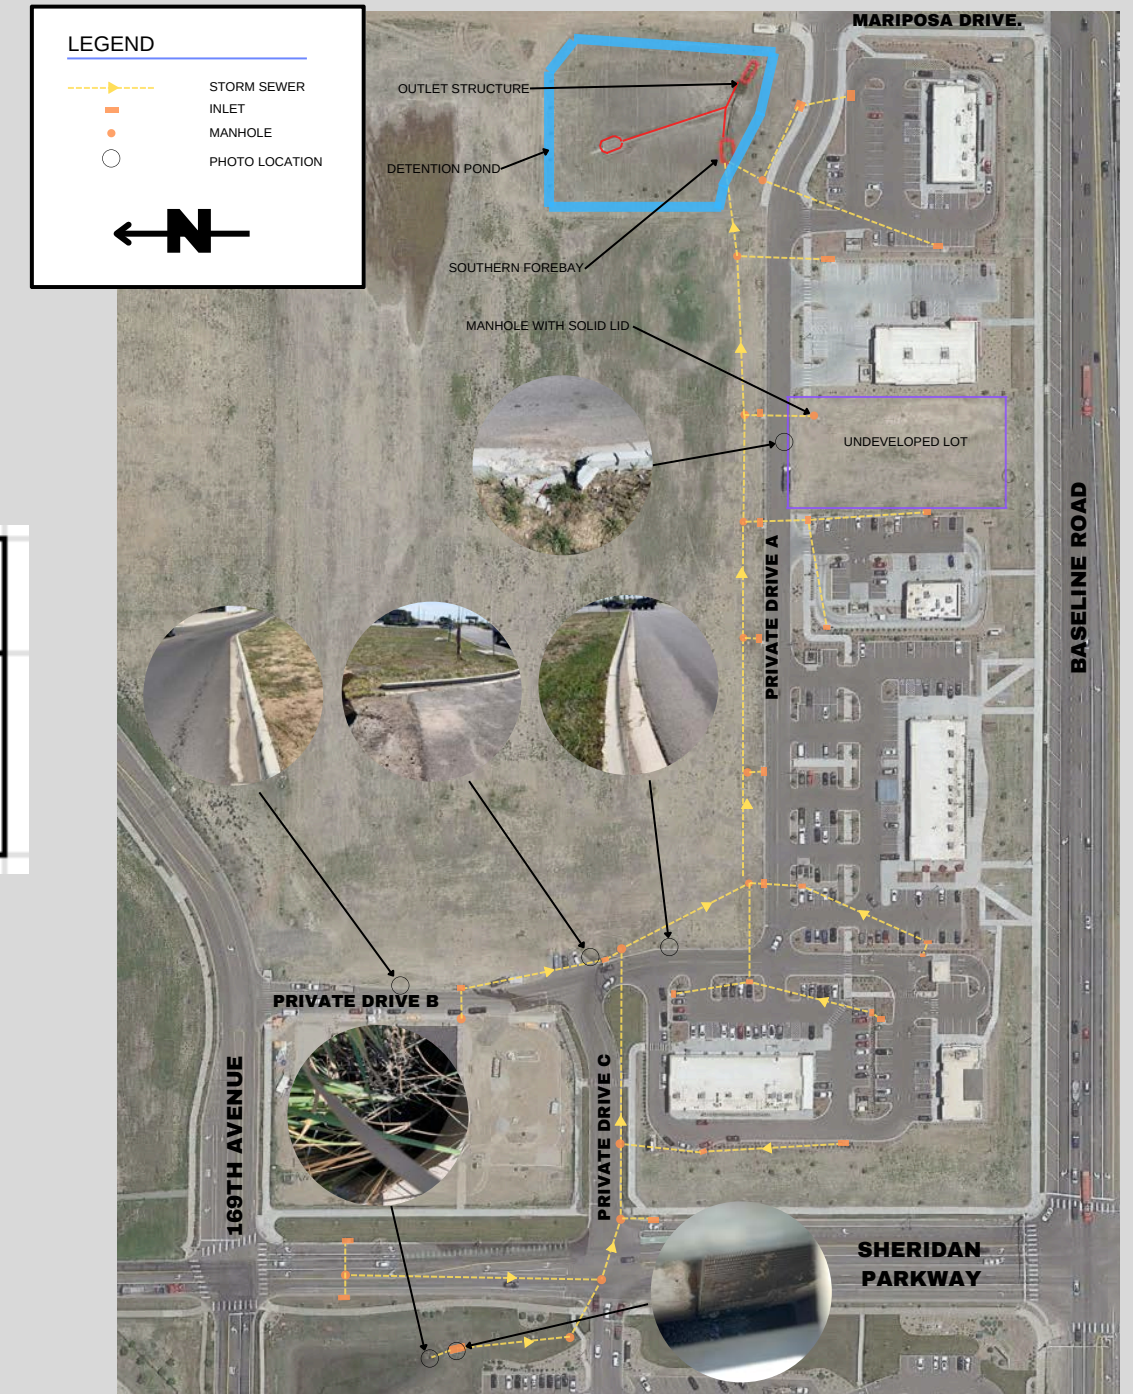
Client C:	Developer on jurisdictional boundary
Lesson:	Audit the source of sediment and use contractors strategically

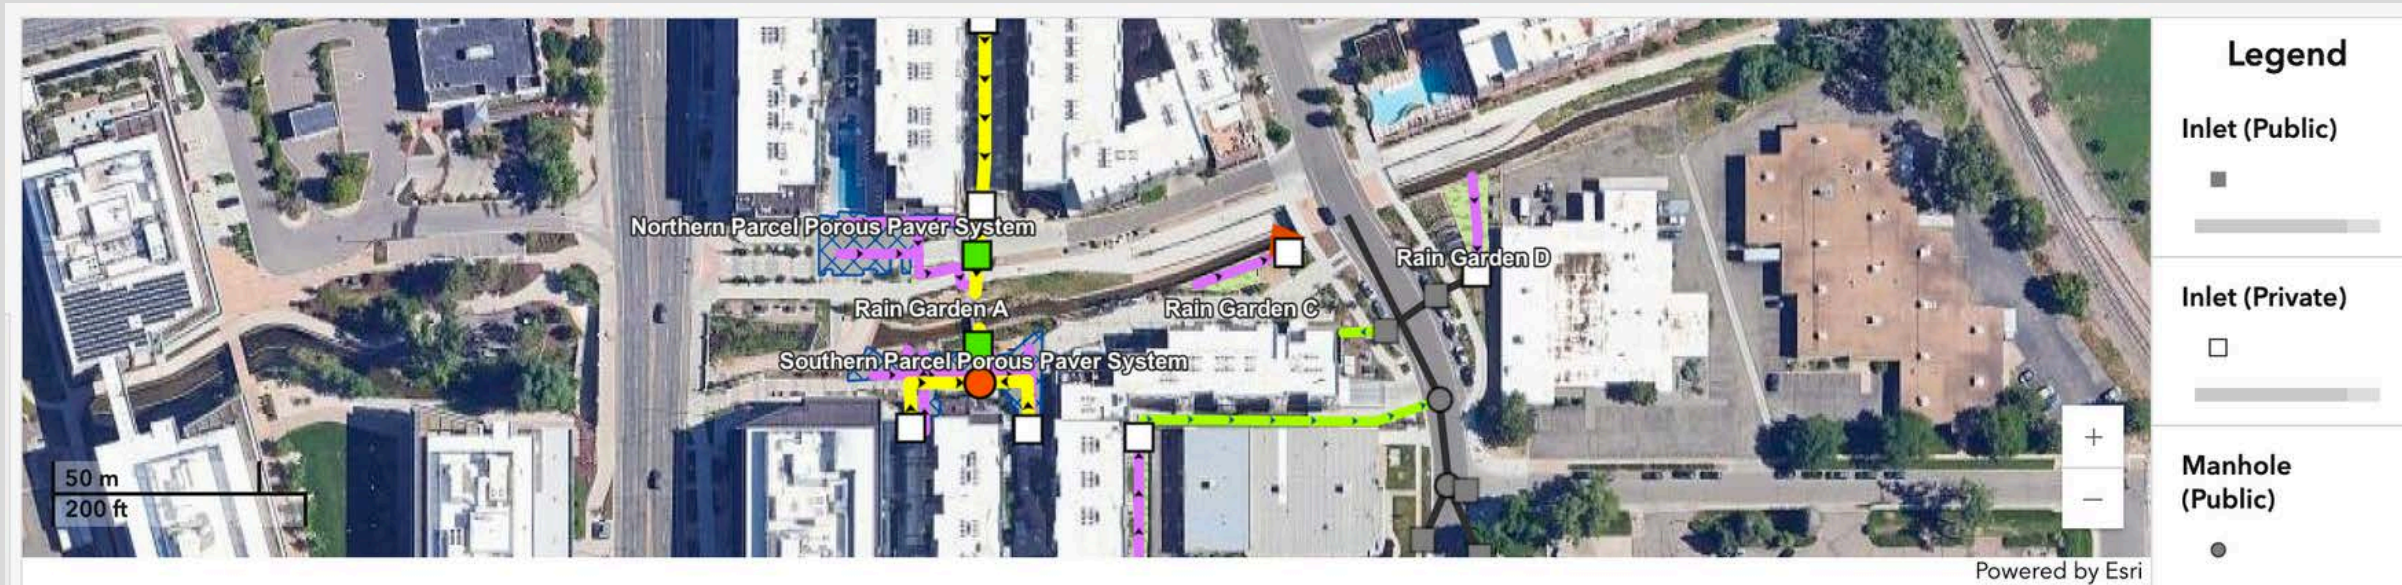
Client Profile: Assets mapped, inspection and maintenance information stored within shape file, assets are maintained regular to stay in compliance

To explore details of individual Stormwater Control Measures, zoom into the map and click on an item. A panel will appear with relevant inspection information.
