SUSTAINABLE
RUNOFF SOLUTIONS

Routine Maintenance Always Saves Money: How to be Pro-Active

1 Permeable Interlocking Concrete Pavers (PICP)

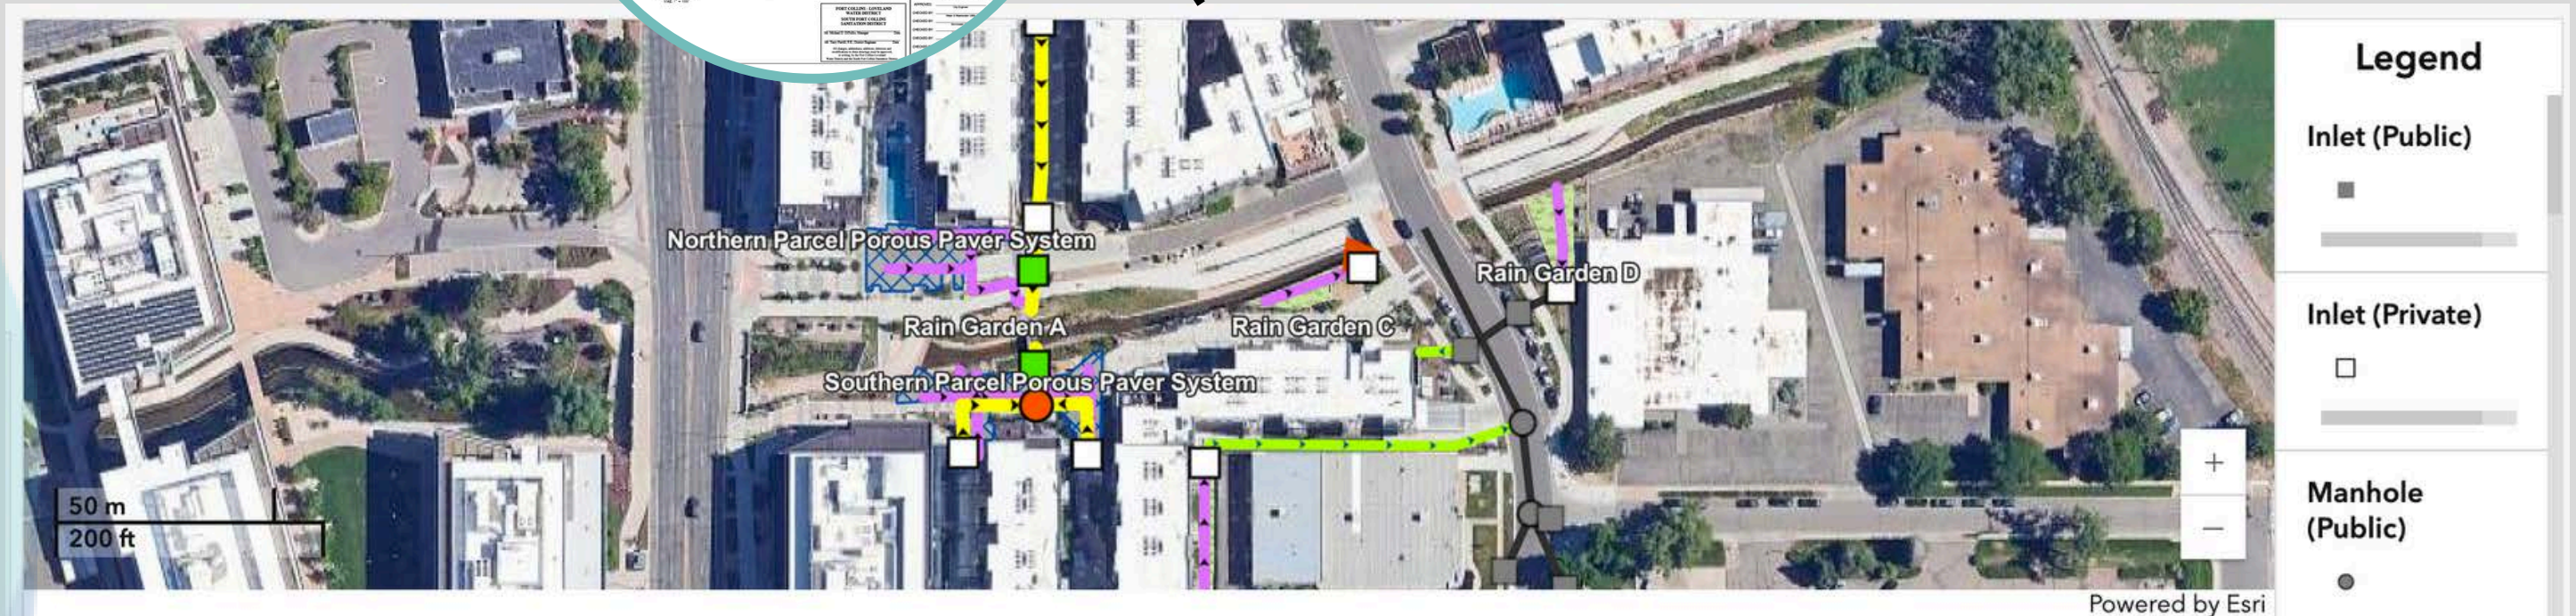
To explore details of individual Stormwater Control Measures, zoom into the map and click on an item. A panel will appear with relevant inspection information.

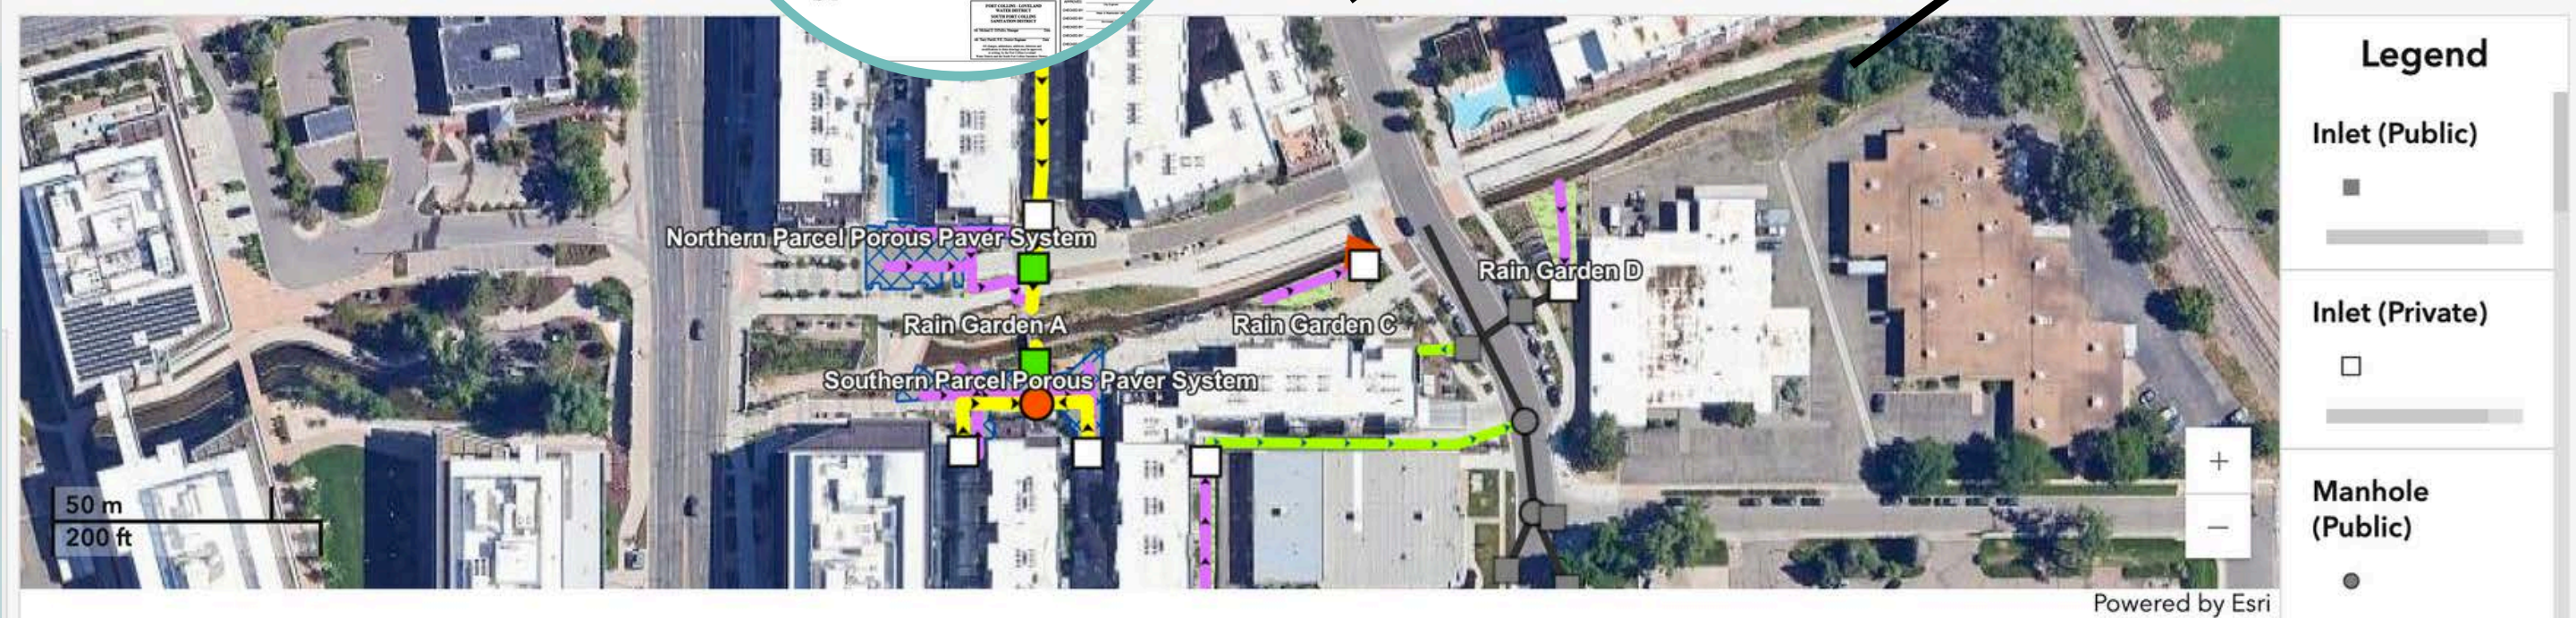
<p>Details</p> <p>To explore details of individual Stormwater Control Measures, zoom into the map and click on an item. A panel will appear with relevant inspection information.</p> <p>Below are some links that will guide you to supplementary documentation. From there, you can easily download the documents for your records.</p> <p>Construction Plans: View</p>	<p>Routine Maintenance Indicator</p> <p>38</p> <p>Indicator populates when SCMs have a condition score of 7 or higher.</p>	<p>Restorative Maintenance Indicator</p> <p>0</p> <p>Indicator populates when SCMs have a condition score between 4 and 6.</p>	<p>Reconstruction Indicator</p> <p>0</p> <p>Indicator populates when SCMs have a condition score between 1 and 3.</p>
--	--	--	---

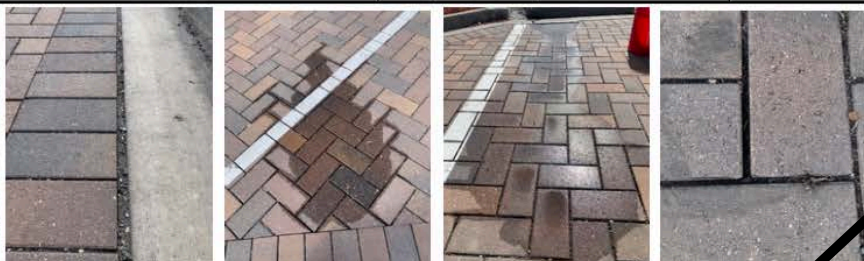
SUSTAINABLE RUNOFF SOLUTIONS Permeable Pavement Inspection Form				
Property Name:		Redtail Ponds PSH		
Property Address:		5080 Fossil Blvd, Fort Collins, CO 80525		
SCM ID	PP1, PP2, & PP3			
SCM Description:	Three permeable concrete interlocking paver areas within parking stalls			
SCM Location:	Front (west) drive area			
Weather Conditions:	Clear, slight breeze 52 degrees	Rain in Last 48 Hrs?	None	
Inspection Item	Comments/Observations	Condition Score		
Pavement Surface	Fair condition, some signs of fluid leakage from vehicles. Some sign of block settlement adjacent to concrete ribbon on PP3.	7		
Pavement Joints	Sediment and organics build up seen in paver joints. Joint filter material not seen consistently within joints	5		
Underdrain	No signs of sediment within underdrain as seen from cleanout port	8		
Permeability Test (minimum 3/10,000 sf)	Test Location	Test Results (flow spread)	Pass/Fail

1	western stall of PP1	8-foot flow spread	Pass	
2	western stall of PP2	>10-foot flow spread	Fail	
3	3rd stall from the west on PP3	> 10-foot flow spread	Fail	
Note the following conditions:				
sediment accumulation	standing water not draining	erosion or settlement observed on surface		
missing or low joint aggregate	oil observed	access ports or manholes not accessible		
structural deficiencies or issues	weed growth within pavers			
Inspection Photos/Sketch:

Maintenance Recommendations: Conduct restorative maintenance on all PICP areas.			
	Overall Condition Score	5		
	Overall condition score is a 1 to 10 scale where 10 is a newly functional asset and 1 is fully failing. A score of 3 and below will generally require some level of maintenance
